EVALUATION OF FOUR DRIVE CHAINS FOR SERVICE IN SEA WATER

NRL MEMORANDUM REPORT 4560

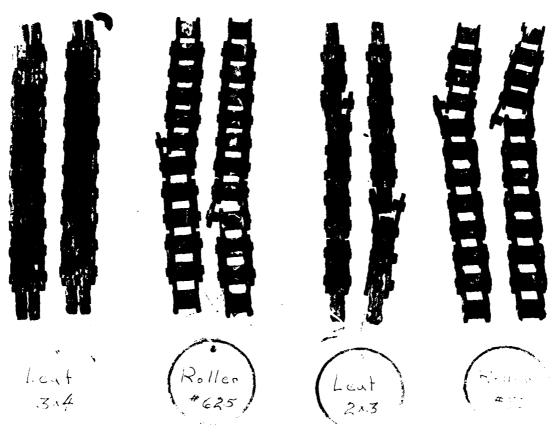
Segments of each chain were loaded to 2000 pounds constant load for periods of two and four weeks. These chains were submerged in sea water and loaded through carefully calibrated air cylinders supplied with pressure-regulated nitrogen gas. After the desired time under load was achieved, specimens of approximately 7.5 inches in length were cut from each chain segment. These specimens were cyclicly loaded on a sinusoidal load-time profile of 3 Hz between loads of 2000 and 3500 pounds. Sea water was dripped over the specimens during cyclic loading. All specimens tested in this manner failed with results as tabulated in Table 1. The series of specimens which failed under cyclic loading, after a two-week period with static loading, are shown in Figure 1.

It is important to note that the failures in the roller chains are identical to those which occurred in the #50 chain while in service. In the earlier NRL study [1] the chains were not pre-conditioned at a constant load before fatigue testing and the in-service type chain failures were not reproduced. The earlier laboratory fatigue failures [1] occurred consistently in the link plates rather than in the pins. After time-under-load in sea water, all the laboratory failures in the roller chain were pin failures. This would seem to indicate that small cracks are initiated in the pins during static loading and then grow to cause failure during cyclic loading. This is especially damaging for the case hardened pins of the #50 chain. The harder outer case is more susceptible to cracking and such cracking greatly reduces the strength of the pin. The through-hardened pins of the #625 chain are less brittle on the outer surface so should be more resistant to crack initiation.

Fig. 1 — Specimens of four types of chains failed by cyclic loading after two weeks of sustained static loading in sea water.

Results of this study indicate that replacement of the #50 roller chain with any of the other three would be an improvement offering an advantage in both breaking strength and fatigue life. Since replacing the #50 chain with the #625 chain would not involve any other change or redesign, it seems logical that this should be the first and immediate action. This substitution would give an increase of 18% in the quoted static breaking strength and more than double the expected fatigue life. This replacement should up grade the present marginal system to an acceptable operating life without costly redesign. If this still proves to be unsatisfactory it may then be necessary to redesign for use of the 3 × 4 leaf chain.

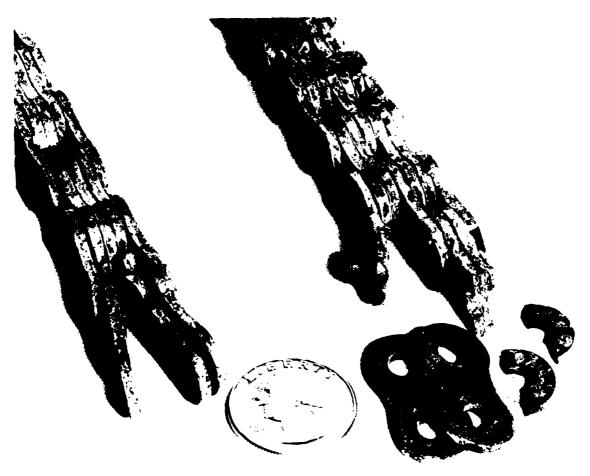
The larger diameter pins of the two leaf chains were not as highly stressed and failure still tended to initiate at the pin holes in the chain plates. After several of these plates had failed the pins experienced more bending load (as opposed to shear loading) and they too eventually failed producing combination plate and pin failures as shown in Figure 2. Pin failures were more likely in the more highly stressed 2×3 leaf chains. The 3×4 leaf specimens all failed either in the plates or in a pin-plate combination.

Fig. 2 — Combination plate and pin failures occurring in leaf-chain specimens subjected to cyclic loading after four weeks of sustained static loading in sea water.
